# Manhole Inspection Summary

Manhole # S33WW1005MH

Insp Date: **1/24/07 2:16 PM**

**Location** Address: **5202 SPRINGLAKE WAY**

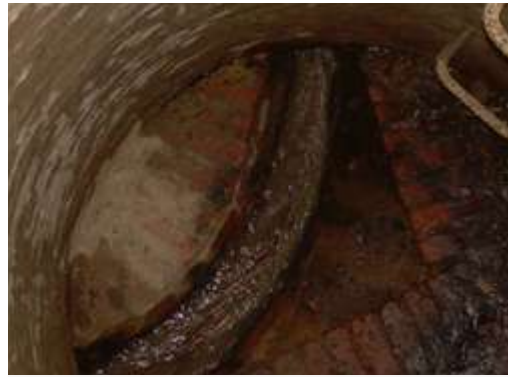
Top View

Corroded steps. Evidence of surcharge - Bench debris.

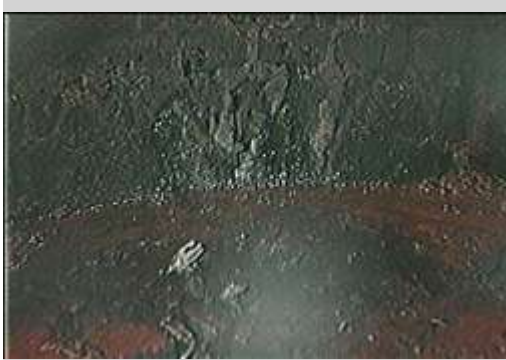
Defect

Barrel deterioration and infiltration. Bench infiltration.

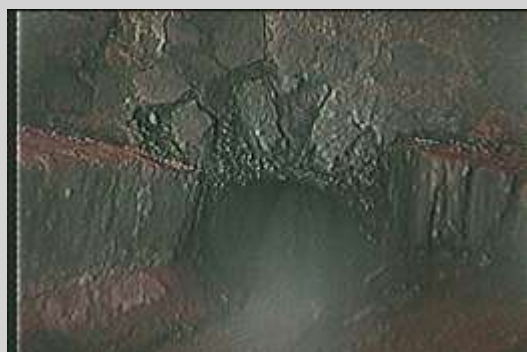
Pipe Out @ 12 O'Clock

Infiltration: **Evidence** Pipe Seal Cond: **Cracked**

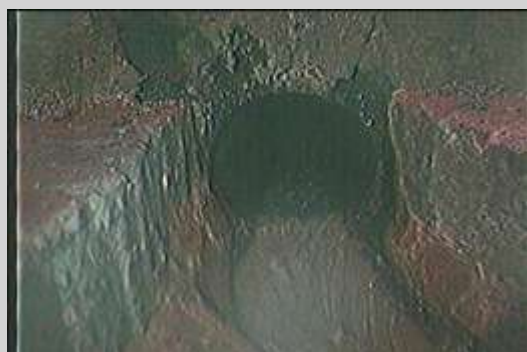
Pipe In @ 8 O'Clock

Infiltration: **Evidence** Pipe Seal Cond: **Cracked**
